**PERFORMANCE OF A NOURISHED SAND BEACH
IN UPPER GULF OF THAILAND**

JIRAT LAKSANALAMAI AND NOBUHISA KOBAYASHI

RESEARCH REPORT NO. CACR-21-03
NOVEMBER 2021

CENTER FOR APPLIED COASTAL RESEARCH
University of Delaware
Newark, Delaware 19716

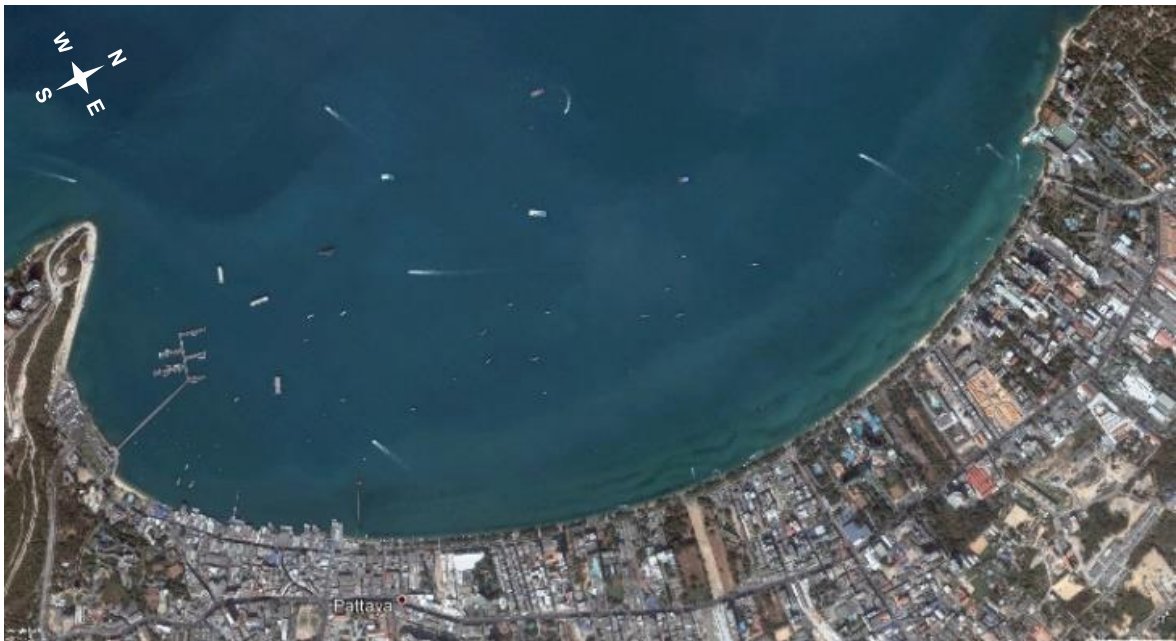
Satellite images of Pattaya beach are available since 2005 (Google Earth Pro, TerraMetrics and Maxar Technologies). The dry beach width in the satellite images was very narrow even in 2005. This study deals with the interval of 2019-2021. Figure 2.1 shows satellite images starting from January 4, 2005 (well before the 2018 beach nourishment) up to August 9, 2021 (more than two years after the beach nourishment.)

2005/01/04 (pre-nourishment)

2019/11/25 (post-nourishment)

2021/08/09 (post-nourishment after more than two years)

Figure 2.1 Pattaya beach (Google Earth Pro, TerraMetrics and Maxar Technologies) starting from January 4, 2005 up to August 9, 2021.

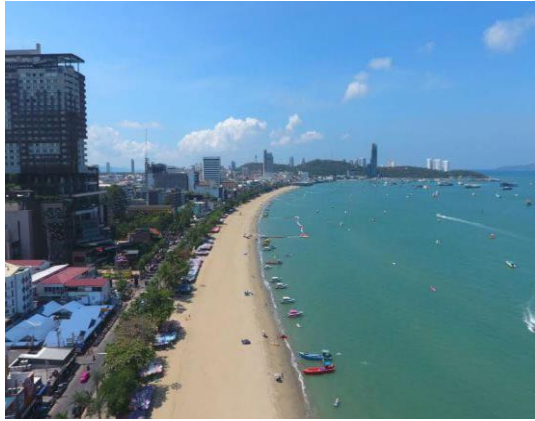
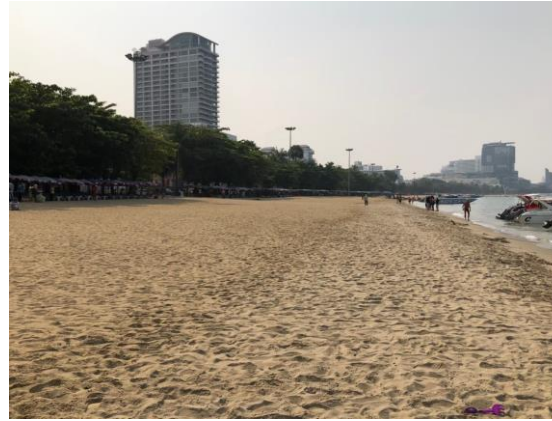
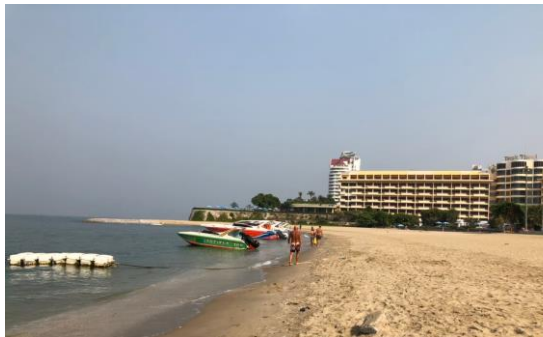
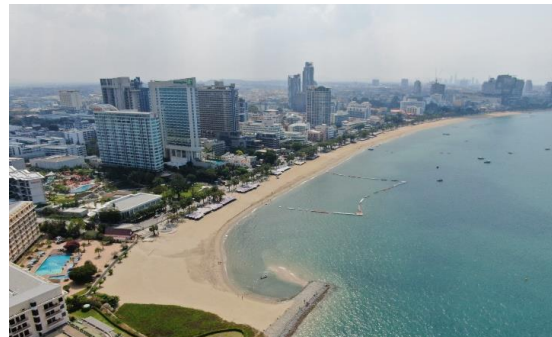
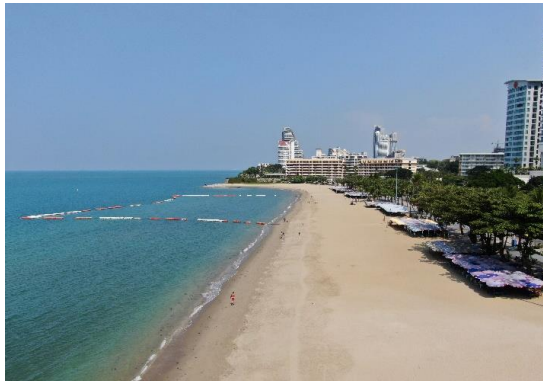
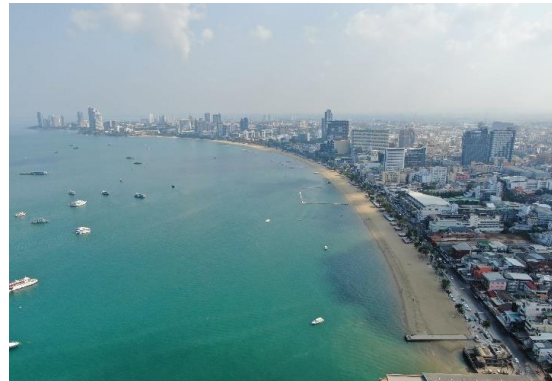
After dredged sand placement, the bathymetry and topography were surveyed in February 2019, February 2020, and January 2021. The borrow site with medium sand of 0.3-0.4 mm median diameter was 20 km from Pattaya beach. Terminal groins were constructed in 2018. The sand was dredged and transported to a booster pump station ship. The transferred sand was pumped through pipelines on Pattaya beach along the curved shoreline of 2.8 km length between the terminal groins (60 m long) at the south and north (left and right in Figure 2.1) ends. The placed sand volume was 363,000 m³, corresponding to the cross-sectional area increase of 130 m². The beach width above the mean sea level was 57 m. The foreshore slope was 0.1. Six photos in Figure 2.2 (a)-(f) show the transformation of Pattaya beach during 2019-2021 after the sand placement.

a. After sand placement (Feb 2019)

b. After one year (Feb 2020)

c. North terminal groin (Feb 2020)

d. North terminal groin (Jan 2021)

e. After two years (Jan 2021)

f. South terminal groin (Jan 2021)

Figure 2.2 Pattaya beach during 2019-2021 after sand placement.

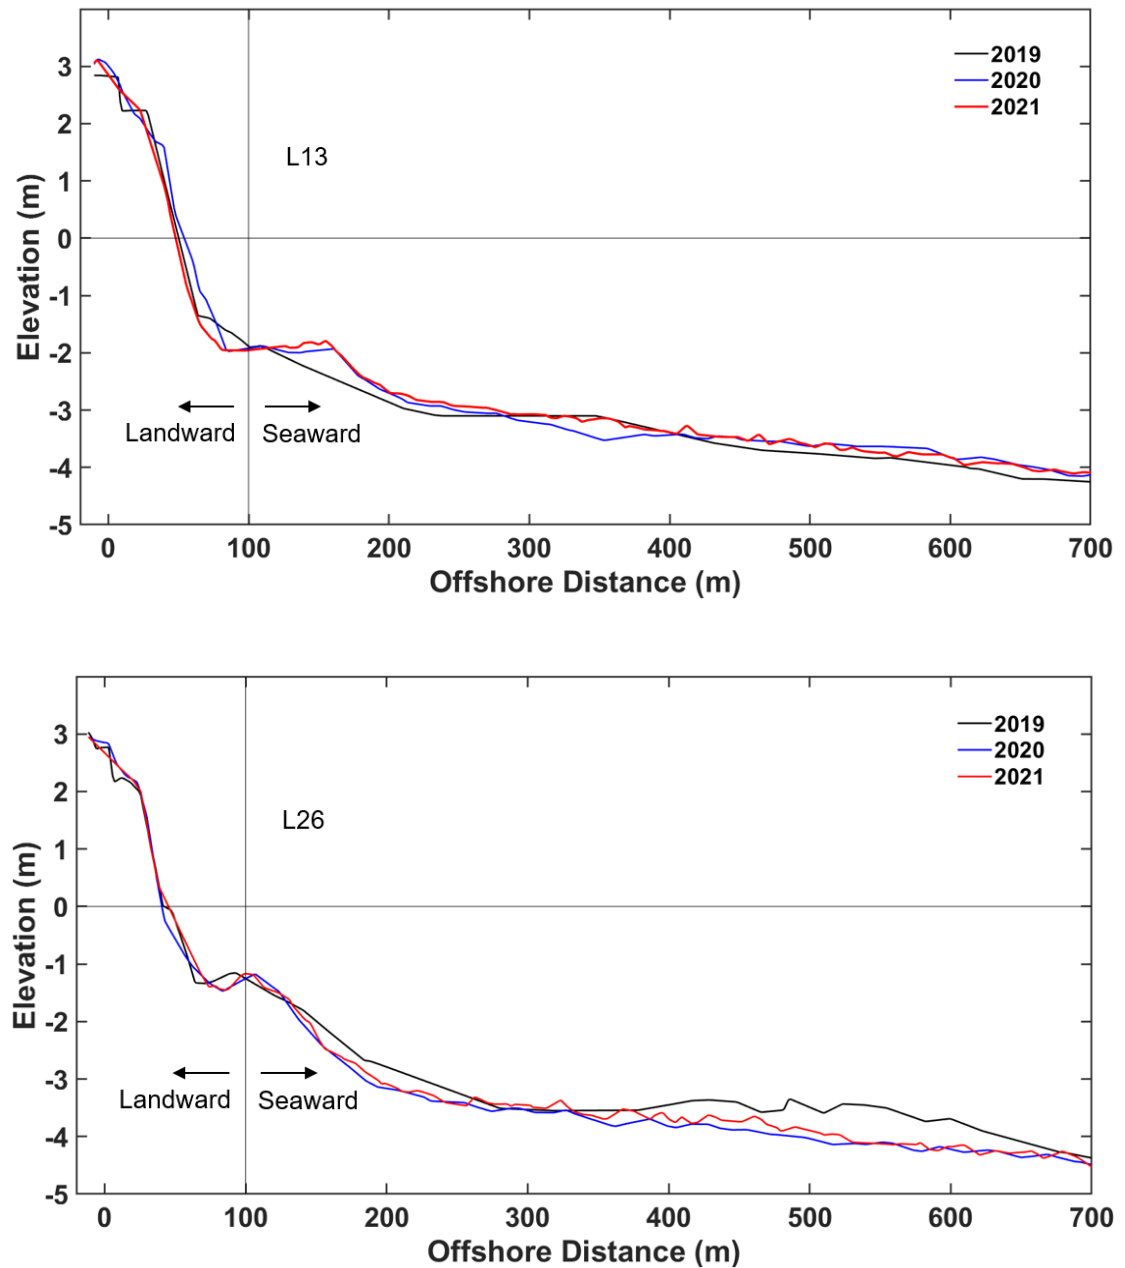
Figure 2.4 Beach profiles in 2019, 2020, and 2021 along Line L13 with offshore accretion and Line L26 with offshore erosion during 2019-2020.

Figure 2.4 shows the beach profiles along with L13 and L26 in 2019, 2020, and 2021. The elevation is relative to the mean sea level. The offshore distance is from the survey reference point located 10 m seaward of the vertical wall with its crest elevation of 3 m. The nourished berm elevation was increased from 2.2 m to 2.8 m in front of the wall. The beach profile evolution diverged at the offshore distance of approximately 100 m for L1-L30. The seaward limit was set at the offshore distance of 700 m of limited bottom elevation changes. The offshore distance of 100 m is used to separate the landward and seaward zones of different profile evolution patterns. The placed sand was eroded during 2019-2021. The water depth at this separation point decreased from about 2 m at L1 to 1 m at L30 because of the northward decrease of the beach slope in Figure 2.3. The seaward zone is accretional for L13 and erosional for L26. The pronounced erosion in the seaward zone of L26 was not expected for the microtidal beach of medium sand in an environment of low wave energy.

the other hand, the sand loss between L21-L30 decreased from 22K during 2019-2020 to 4K during 2020-2021, possibly because of the nourished profile approaching equilibrium (Figure 2.4). The erosion trend in the landward zone in Figure 3.6 was continuing between L1-L20 but diminishing between L21-L30.

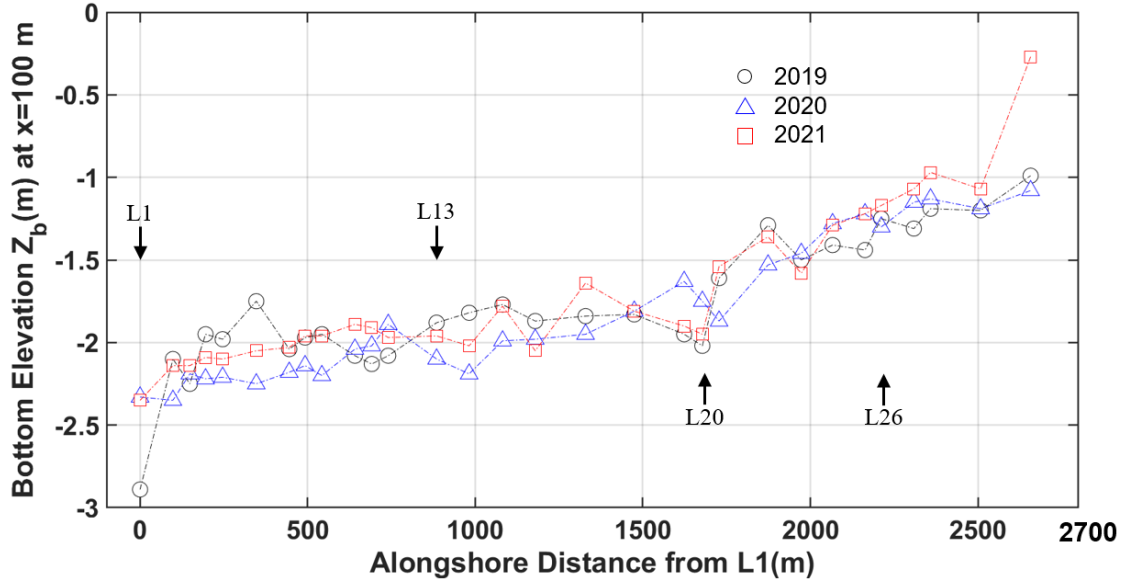
Figure 3.2 Bottom elevation Z_b at $x = 100$ m along L1–L30 during 2019–2021.

Figure 3.2 shows the alongshore increase of the bottom elevation Z_b at $x = 100$ m from the south to the north in 2019, 2020, and 2021. The temporal change of Z_b at $x = 100$ m was relatively small except at L1 and L30 next to the south and north groins in Figure 2.3. The separation of the landward and seaward zones at $x = 100$ m may be reasonable in view of Figure 3.2.

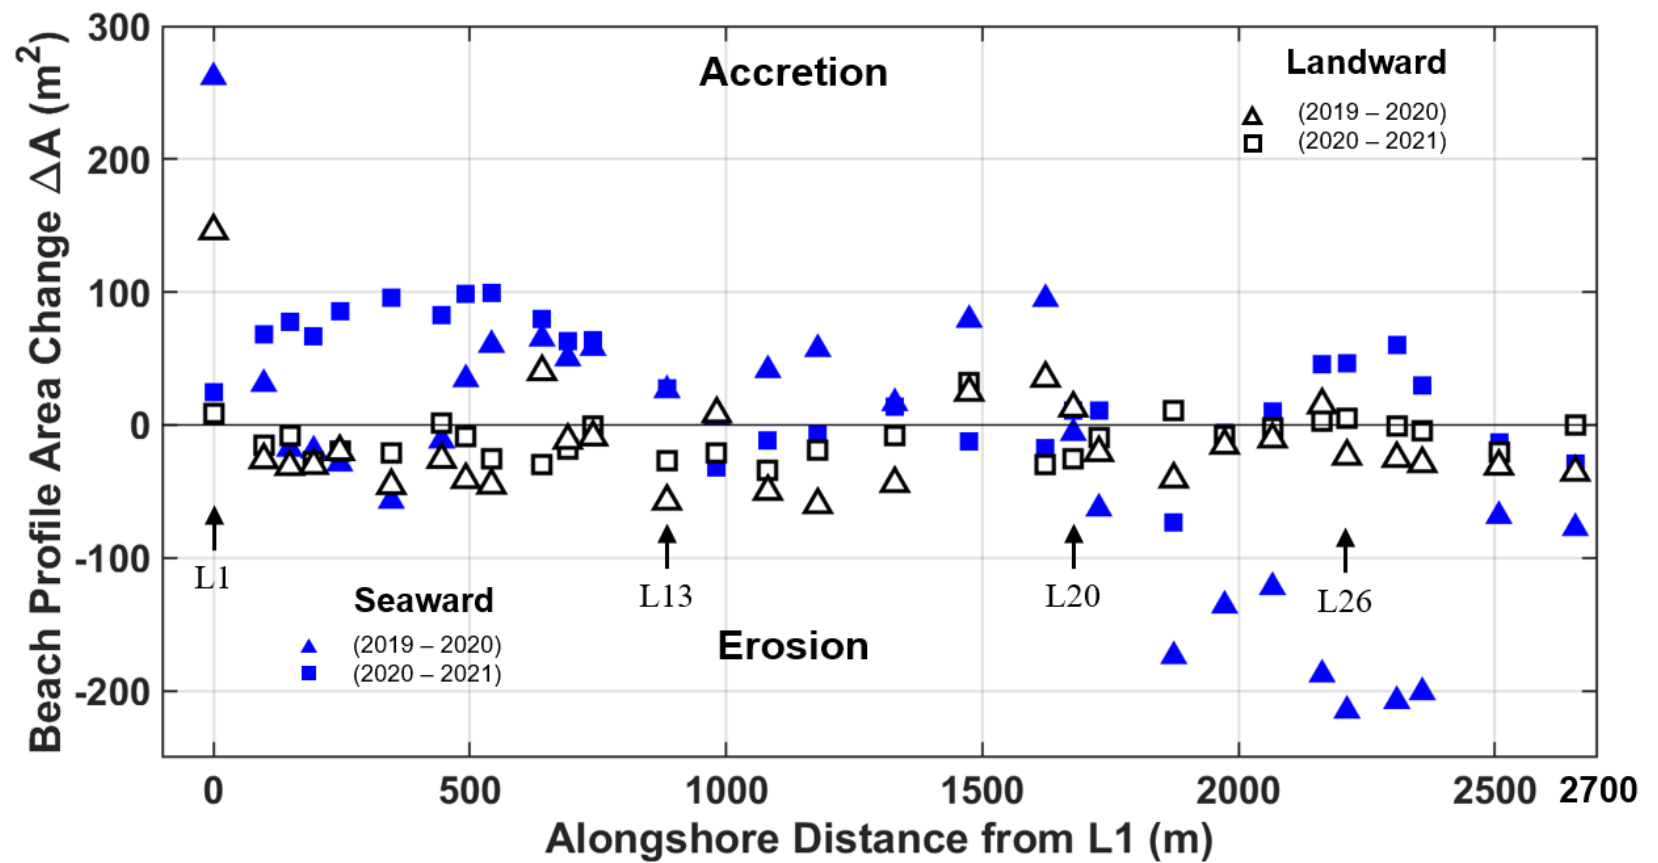
The four different values of ΔA in the two zones and during the two intervals are plotted for each of the 30 cross-shore lines in Figure 3.3 as a function of the landward alongshore distance from L1. For clarity, the area changes in the landward and seaward zones are plotted separately in Figure 3.4 and 3.5, respectively. It is noted that the beach profile area changes from 2015 (before nourishment) to 2019 were presented by Laksanalamai and Kobayashi (2021). The area increase in the landward zone during 2015-2019 was approximately 130 m².

Figure 3.3 Beach profile area change ΔA in landward and seaward zones along L1–L30 during 2019–2020 and 2020–2021.

The area changes ΔA listed in Table 3.1 and plotted in Figures 3.3-3.5 are explained to understand the trends of the bathymetric changes. L1 is excluded because the profile L1 may have reached equilibrium. Figure 3.6 compares the area changes in the landward zone during 2019-2020 and 2020-2021. The negative value of ΔA implies erosion of sand placed in the landward zone before 2019. The range of $\Delta A = (-60)$ -40 m^2 during 2019-2020 was reduced to $\Delta A = (-34)$ -32 m^2 during 2020-2021. The range reduction was more apparent for L21-L30. The average ΔA during 2020-2021 was -16 m^2 for L2-L20 and -2.6 m^2 for L21-L30. The landward zone for L21-L30 may be approaching equilibrium.

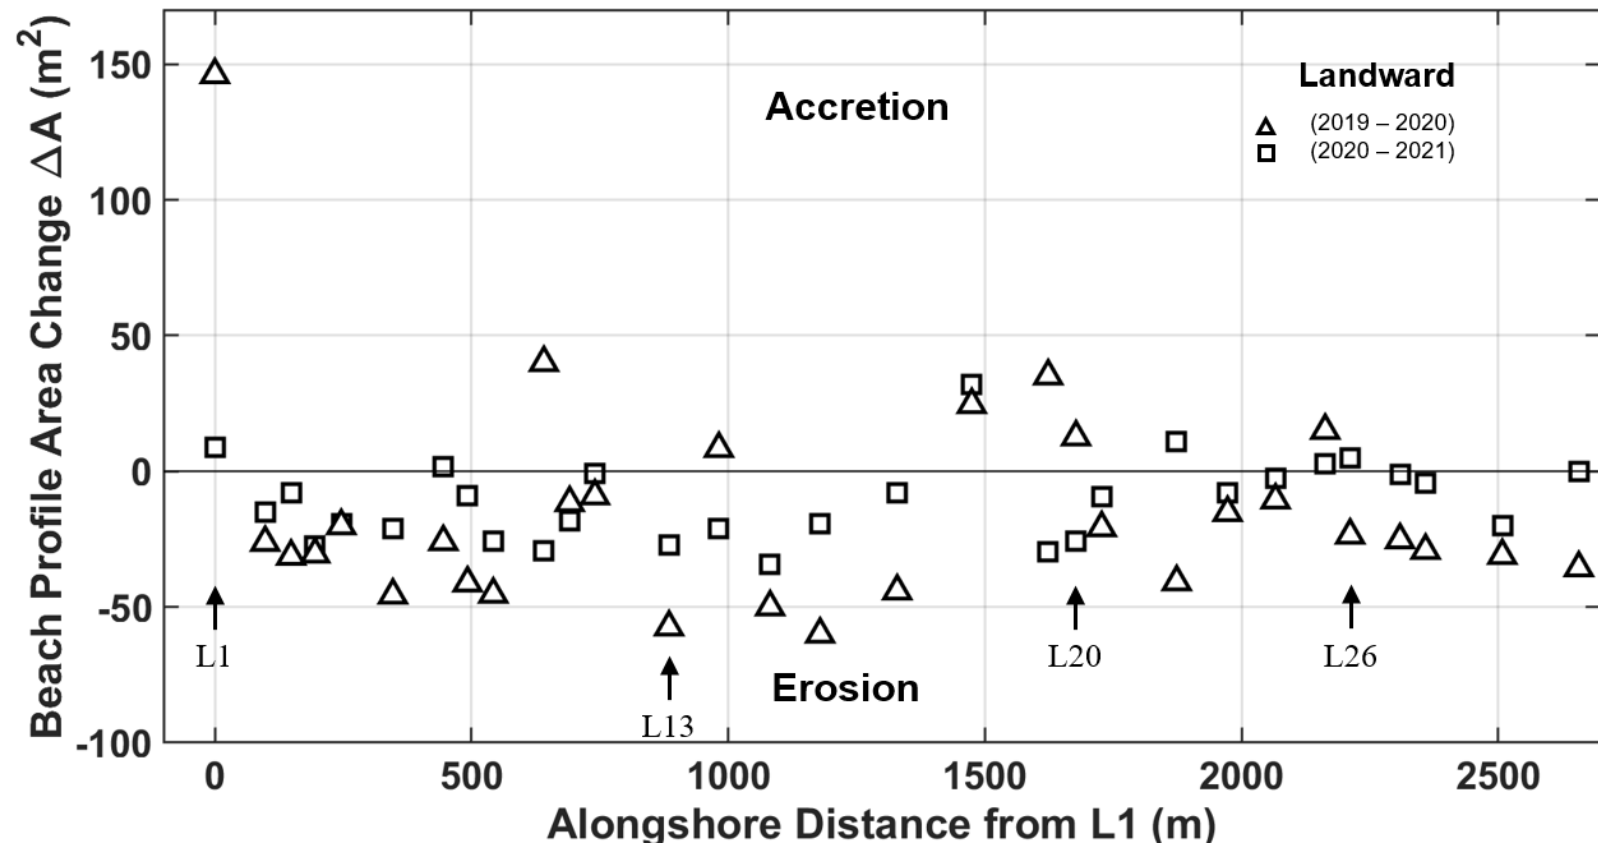
Figure 3.4 Beach profile area change ΔA in landward zone along L1–L30 during 2019–2020 and 2020–2021.

No sand was placed along L1 during 2015-2019 because sand accretion was expected north of the south groin. The area changes in the landward and seaward zones along L1 were largely positive (accretion) during 2019-2020 and became small, indicating the sand fullness along L1 next to the south groin. The area changes ΔA in the landward zone (Figure 3.4) during 2019-2020 were negative (erosion) except for L1, 10, 14, 18-20, and 25 (Table 3.1) where sand accretion occurred. The area changes in the landward zone during 2020-2021 were mostly negative (erosion) and varied alongshore as explained subsequently. The area changes in the seaward zone (Figure 3.5) during 2019-2020 were mostly positive for L2-L19 and negative for L20-L30. Then during 2020-2021, ΔA in the seaward zone remained accretional for L2-L13 but became slightly erosional for L14-L19. The area changes in the seaward zone for L21-L30 became accretional except L22, 23, 29, 30 with slight erosion.

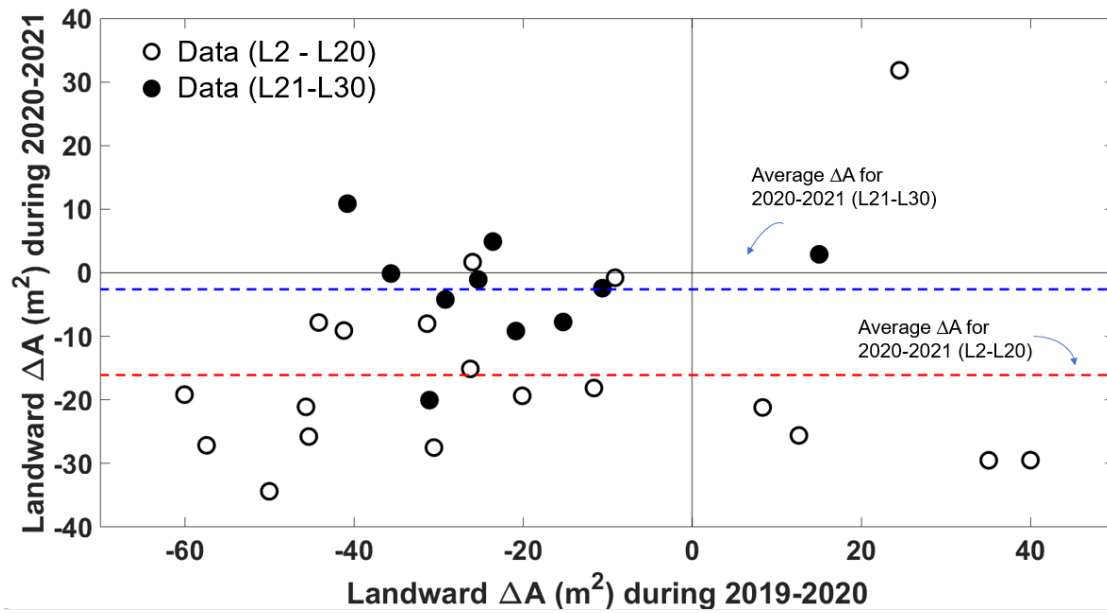
Figure 3.6 Comparison between landward ΔA during 2019–2020 and 2020-2021 where small ΔA for L21-L30 during 2020-2021.

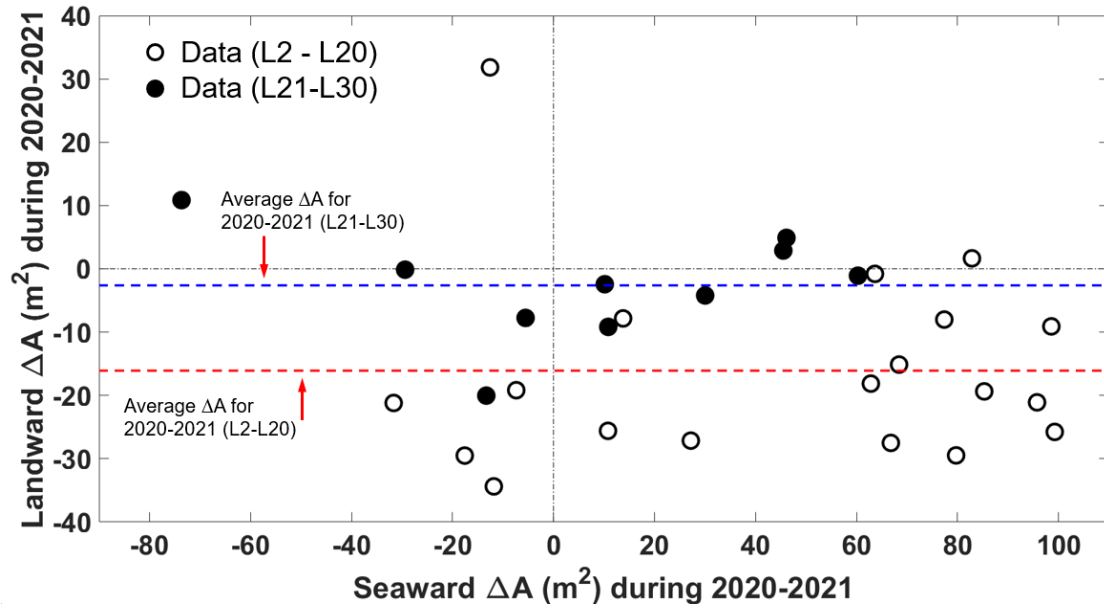
Sand placed in the landward zone may be eroded and transported to the seaward zone or in the downdrift direction (Figlus and Kobayashi 2008). Figure 3.7 compares the area changes in the landward and seaward zones during 2020-2021. The correlation between the landward and seaward area changes was practically zero during 2020-2021 as was the case with the duration of 2019-2020 (Laksanalamai and Kobayashi 2021). The range of $\Delta A = (-74)-99 m^2$ in the seaward zone for 2020-2021 was definitely wider than the corresponding range in the landward zone. The wider range in the seaward zone persisted even for L21-L30. The area changes in the landward and seaward zones were not related on this nourished beach exposed to small waves with the average significant wave height of 0.2 m.

Figure 3.7 Comparison between seaward ΔA and landward ΔA during 2020–2021.

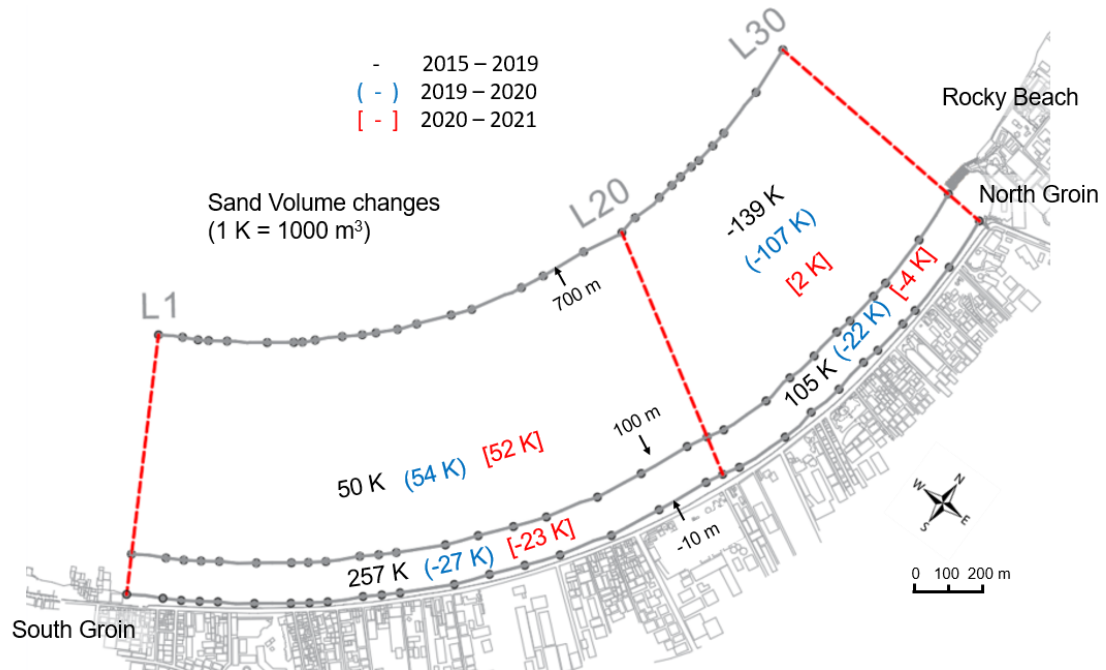
Sand volume changes (ΔV) for each of the 29 segments are calculated using the alongshore length of each segment (Figure 3.1) and the beach profile area change along each cross-shore line (Table 3.1). Sand volume changes in the landward and seaward zones between L1-L20 and L20-L30 are presented in Figure 3.9. Three points represent all the cross-shore lines at the offshore distance of -10, 100, and 700 m. The curved line of -10 m corresponds to the vertical wall with its crest elevation of 3 m. The curved line of 100 m separating the landward and seaward zones terminates near the head of the north groin. The curved line of 700 m is the seaward boundary of noticeable bottom elevation changes in this study, but the bottom elevation changed somewhat outside the study area (Figure 2.3). The data for 2015-2019 presented by Laksanalamai and Kobayashi (2021) are included in Figure 3.9 to interpret the sand volume changes during 2015-2021.

Figure 3.9 Sand volume changes in landward and seaward zones during 2015–2019 in comparison with those changes (in parentheses) during 2019–2020, and (brackets) during 2020–2021, where points (solid circles) along each of L1–L30 are located at the offshore distances of -10, 100, and 700 m.

Figure 3.9 presents the measured sand volume changes concisely. The sand placement in the landward zone before the 2019 survey increased the sand volume by 257K (1K=1,000 m³) and 105K between L1-L20 and L20-L30, respectively. The negative values in the parentheses and brackets indicate the lost sand volumes during 2019-2020 and 2020-2021. The total lost volume was 49K (13.5% of 362K) during 2019-2020 and 27K during 2020-2021. The destination of the lost sand was searched in the survey data. The lost sand could have been transported northward by waves from the southwest and deposited behind the north groin and north of L30 (Figure 2.2d). However, the sand volume change in this area was -7K during 2019-2020. This area was essentially full because of the sand placement in 2018. The sand loss between L1-L20 was 27K during 2019-2020 and decreased slightly to 23K during 2020-2021. On

In the seaward zone, the deposited sand volume between L1-L20 was 50K (54K) [52K] during 2015-2019 (2019-2020) [2020-2021], and the eroded sand volume between L20-L30 of 139K (107K) during 2015-2019 (2019-2020) became practically negligible (2K) during 2020-2021. The persistent accretion trend between L1-L20 and the diminishing erosion trend between L21-L30 are apparent in Figure 3.8. The profile area changes in the landward and seaward zones of a nourished beach are expected to be correlated because of cross-shore sand transport (Figlus and Kobayashi 2008). Figure 3.7 suggests little correlation between the two zones during 2020-2021 as was the case during 2019-2020 (Laksanalamai and Kobayashi 2021). The destination of the eroded sand from the nourished landward zone is uncertain at present. The source of the deposited sand in the seaward zone between L1-L20 is unknown
