THE EFFECT OF MODEL SEAGRASS ON WAVE RUNUP: A LABORATORY INVESTIGATION

ALLISON BRIDGES AND JAMES T. KIRBY

RESEARCH REPORT NO. CACR-08-03
MAY 2008

CENTER FOR APPLIED COASTAL RESEARCH

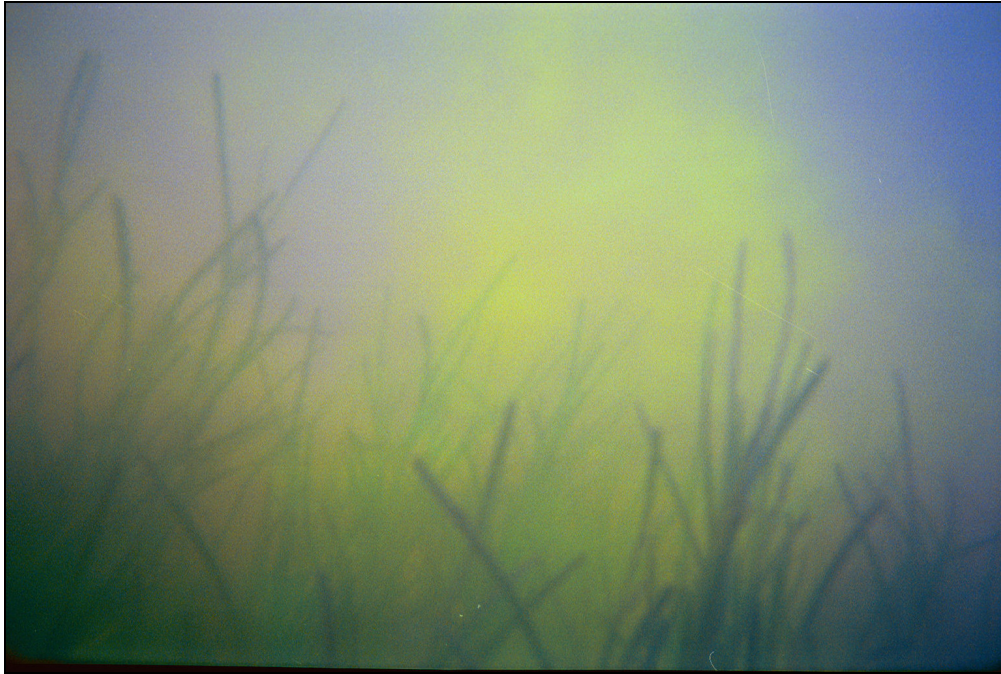
Figure A1 Plan View of Flume at Gage 6 During Case 6 With Plants Run

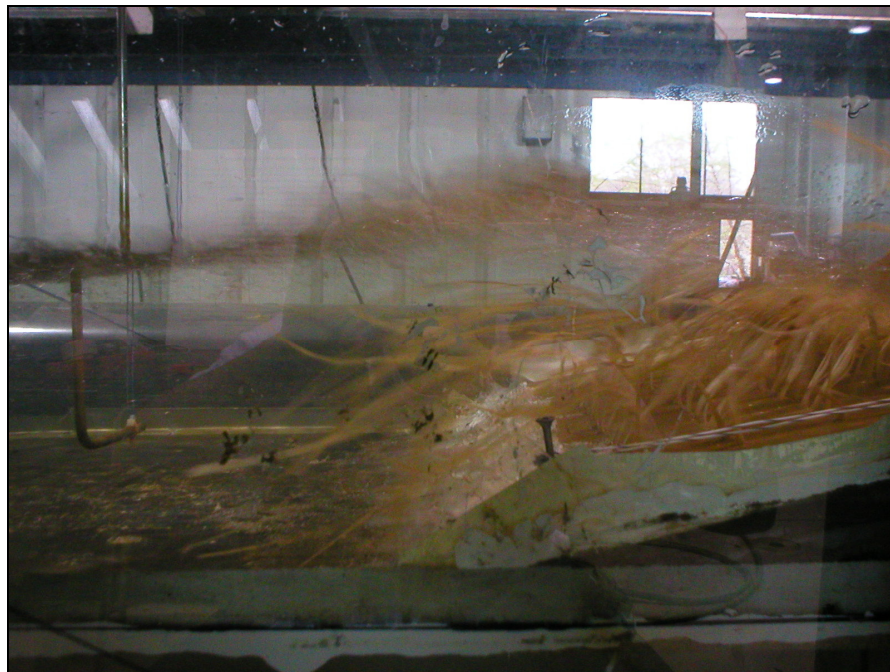
Figure B4 Plan View of Flume at Gage 6 During Case 4 With Plants Run

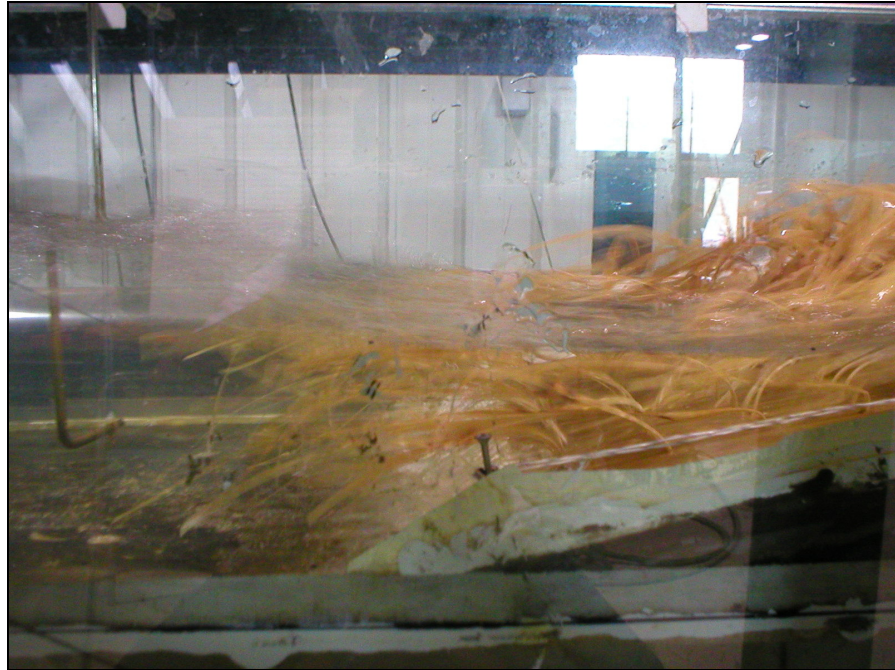
Figure B5 Plan View of Flume at Gage 6 During Case 6 With Plants Run
