EVOLUTION OF A NOURISHED SAND BEACH UNDER LOW WAVE ENERGY IN THAILAND DURING 2015 - 2020

JIRAT LAKSANALAMAI AND NOBUHISA KOBAYASHI

RESEARCH REPORT NO. CACR-21-02 FEBRUARY 2021

CENTER FOR APPLIED COASTAL RESEARCH University of Delaware Newark, Delaware 19716

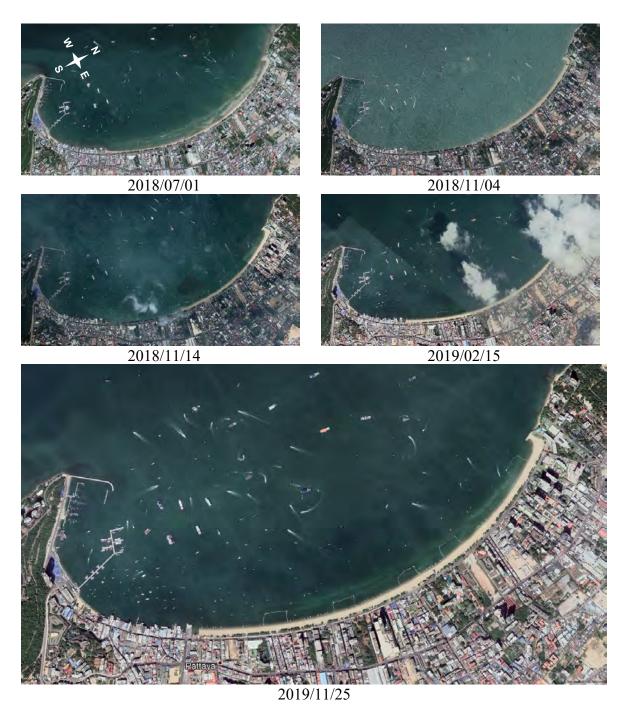
Satellite images of Pattaya beach are available since 2005 (Google Earth Pro, TerraMetrics and Maxar Technologies). The dry beach width in the satellite images was very narrow even in 2005. This study deals with the interval of 2015-2020. Figure 2.1 shows satellite images from January 4, 2005 to November 25, 2019 well before and soon after the beach nourishment.

Figure 2.1 Pattaya beach (Google Earth Pro, TerraMetrics and Maxar Technologies) before and after beach nourishment.

In Figure 2.3, L1 is immediately north of the south groin constructed to reduce local southward longshore sand transport observed at L1. Waves from the south are diffracted around the cape south of Pattaya (see Figure 2.1). The diffracted waves cause southward sand transport in the sheltered zone where a harbor was constructed. L30 is immediately south of the north groin constructed to reduce northward longshore sand transport. L33 is located on a rocky beach north of the nourished beach. The depth contours of 0-2 m between L1-L30 were affected by the sand placement before the 2019 survey. The depth contours of 2-4 m were relatively stationary between L1-L20 but migrated landward, resulting in erosion between L20-L30. L13 and L26 are located in the middle of L1-L20 and L20-L30, respectively.

area was -7K during 2019-2020. This area was essentially full because of the sand placement in 2018 (Figures 2.1 and 2.2). The sum of 49K and 7K is the volume of the lost sand from the landward zone including the area behind the north groin. The lost sand volume of 56K must have been transported offshore to the seaward zone during 2019-2020.

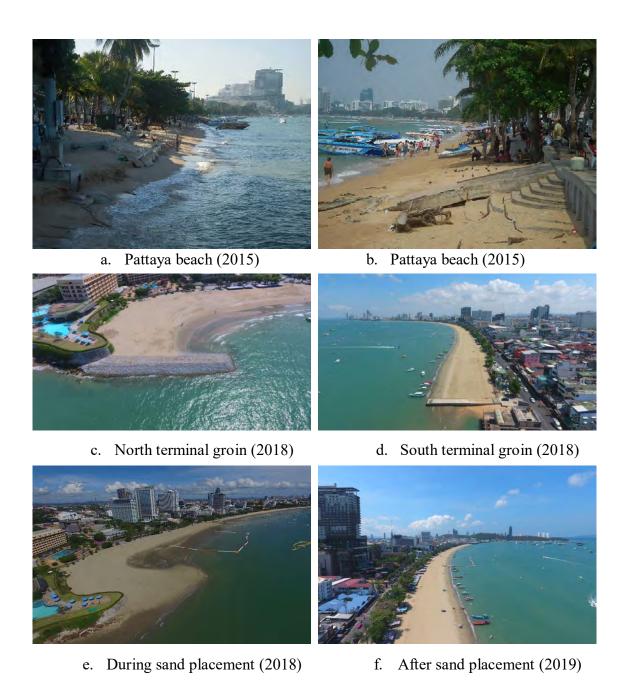
The bathymetry and topography survey were conducted in December 2015, February 2019, and February 2020. The nourishment project was started in 2015 but it took time to locate an offshore borrow site with medium sand of 0.3-0.4 mm median diameter. The borrow site was at a distance of 20 km from Pattaya beach. Terminal groins were constructed in 2018. The sand was dredged and transported to a booster pump station ship. The transferred sand was pumped through pipelines on Pattaya beach along the curved shoreline of 2.8 km length between the terminal groins of 60 m length at the south and north (left and right in Figure 2.1) ends. The placed sand volume was 363,000 m³, corresponding to the cross-sectional area increase of 130 m². The beach width above the mean sea level was 57 m. The foreshore slope was 0.1. Six photos in Figure 2.2 (a)-(f) show the transformation of Pattaya beach before, during and after the sand placement in 2018.

Figure 2.2 Pattaya beach before, during and after sand placement.
